# 24 Hour Turnaround:

Donaldson Hy-Pro Filter Elements Restore Critical Operations in US Paper Mill

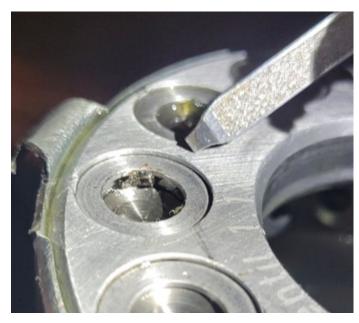
Bypass valve held open by debris, preventing proper sealing.

in one of the valves, preventing it from sealing completely. Although the mill acknowledged the issue, they were unable to address it at the time.

Within just four hours of installing the Donaldson Hy-Pro filters, the system's contamination levels dropped below the target ISO code of 16/14/10, enabling a safe and efficient startup. The bypass valve issue, which had hindered proper sealing, was resolved during the next scheduled filter change. Remarkably, the system maintained a cleanliness level of ISO 15/13/10 or below for the next six months.
